SNAGGING INSPECTION REPORT

The snagging inspection for , Address Hillcrest conducted by Built Safe Properties LLC on October 25, 2025, identified multiple open issues across various areas including the basement, bedrooms, bathrooms, kitchen, living and dining areas, and other internal and external sections of the property.

Address Hill Crest BasementFloor

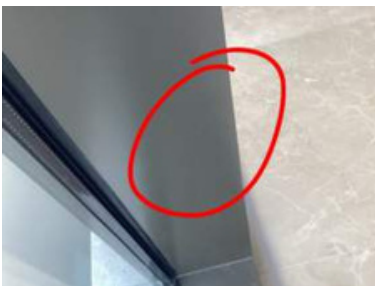
#398 - Floor Moisture level low

Floor Moisture level low

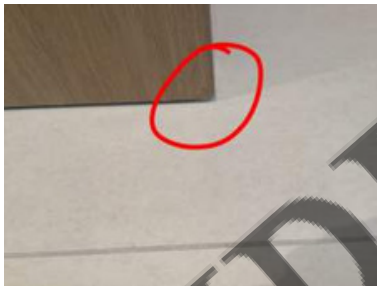
#358 - Near gas pipe wall poor finishing

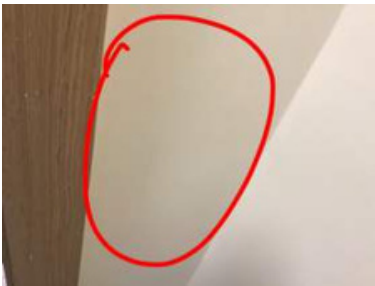
**#352 - Maid room passage wall poor finishing****Open**

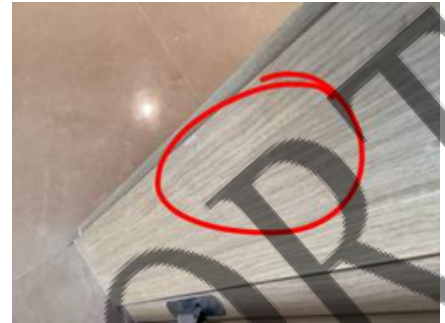
#289 - Curtain frame scratches
